Inspection Report Minerals Regulatory Program Date: July 14, 2009

Mine Name: Opal Mine – ML 46957	Permit Number: S/001/0044		
Operator Name: Stone Art Company	Inspection Date: 07/01/2009		
Inspector(s): Brett Gregory for Tom Munson	Time: 10:00 am Mine Status: Reclaim		
Other Participants: None

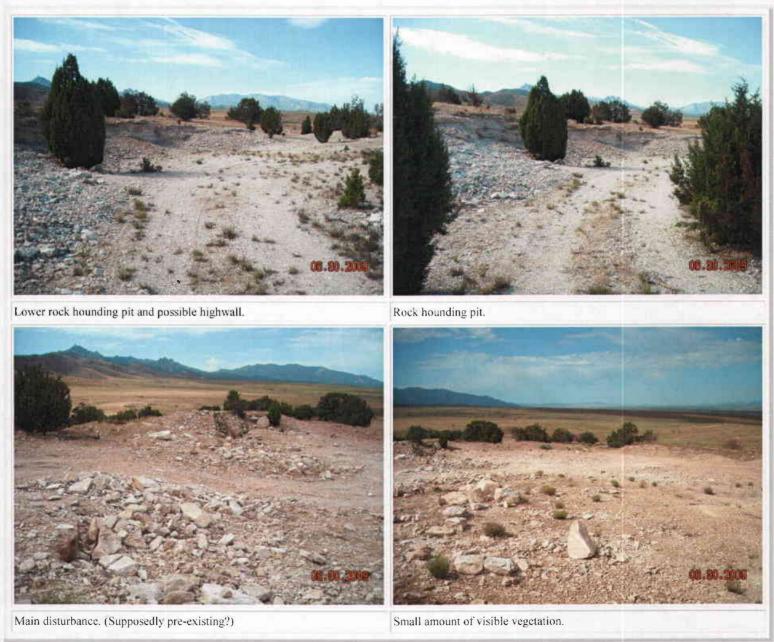
- 2) There was only one small outcrop between four or five feet high that is stable and does not appear to be a safety hazard. I don't believe anything can grow on this outcrop and I recommend it be considered reclaimed. (See pictures.)

- 10) No documentation was provided suggesting the area of hand disturbances had been reseeded. Some plants are growing naturally and can be seen in the photographs. Due to the lack of suitable soil for revegetation, and the pre-existing facts presented by the operator, it is my recommendation the area be considered for closure.
- 12) I walked the area with a GPS handheld unit to map what is currently disturbed; and for possible future documentation.

<u>Conclusions and Recommendations</u>: The site meets reclamation standards. At this time, it is my recommendation that all past due fees be paid, the file closed, and the bond released.
